No. 1435555.6

CLIENT: Vienna Woods 2 Roxburgh Street Newmarket Auckland 1023 Attn.: Damon Jackson	SAMPLE RECEIVED FROM: Vienna Woods SAMPLE DESCRIPTION: Flooring planks: Coating – Lacquer Connection System – T & G	Date Received: 3.10.22
Client Order No.:	Client Reference:	1 of 5

ISO 4760:2022(E) - LAMINATE FLOORING – TOPICAL MOISTURE RESISTANCE – ASSEMBLED JOINT (MODIFIED)

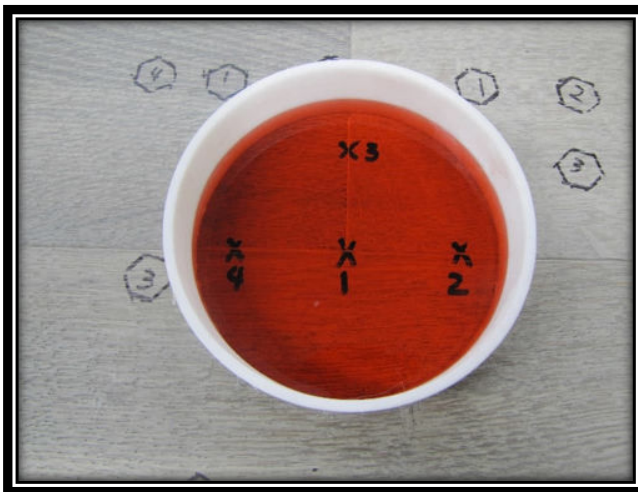
24 hrs With Water

Wet Swell		
	Specimen 1	Specimen 2	Specimen 3
Observations:	The water was able to channel through the joints and puddle on the surface of the planks. However, No water penetration through the joints. There was water left inside the ring after 24 hrs.	No water penetration through the joints.	No water penetration through the joints.

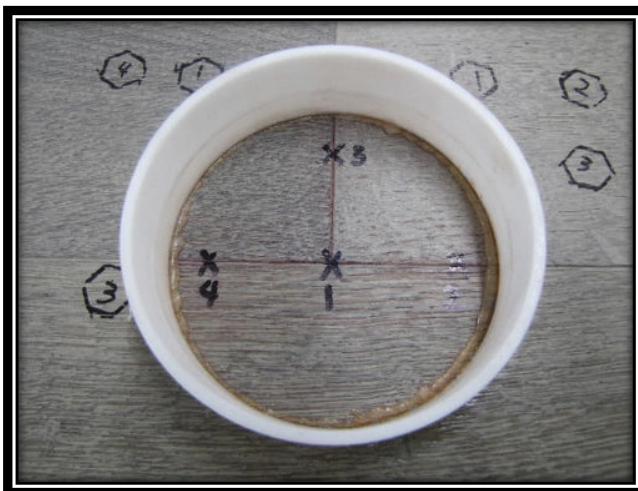
Recovered Swell		
	Specimen 1	Specimen 2	Specimen 3
Disassembly Observations:	No evidence of water penetrating the joints. Water remained on the surface of the joints.	No evidence of water penetrating the joints. Water remained on the surface of the joints.	No evidence of water penetrating the joints. Water remained on the surface of the joints.

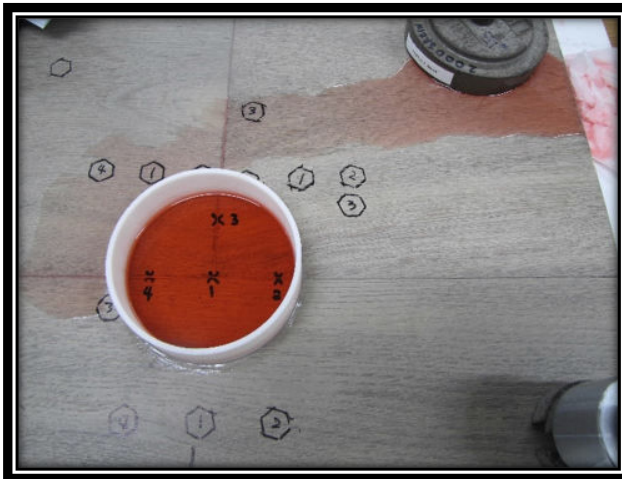
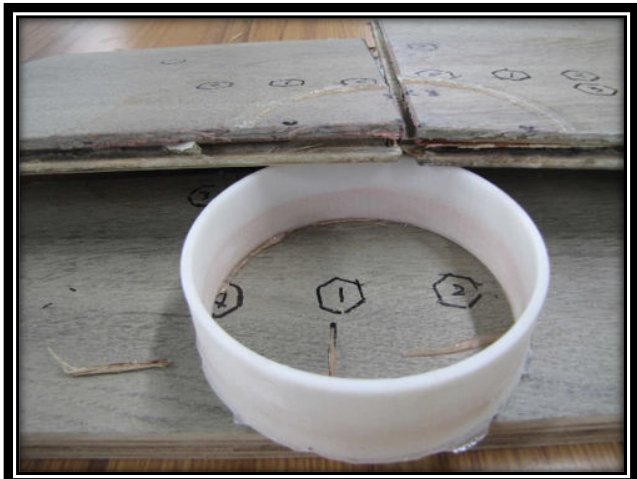
Sample 1 - Water was able to channel through the joints and puddle on the surface of the planks.
